# HOME HARDENING MATTERS

**Special Report on Efficacy of Hurricane Wind Mitigation  
Measures Against EF3 Tornadoes  
Escambia County, Florida • February 2016**

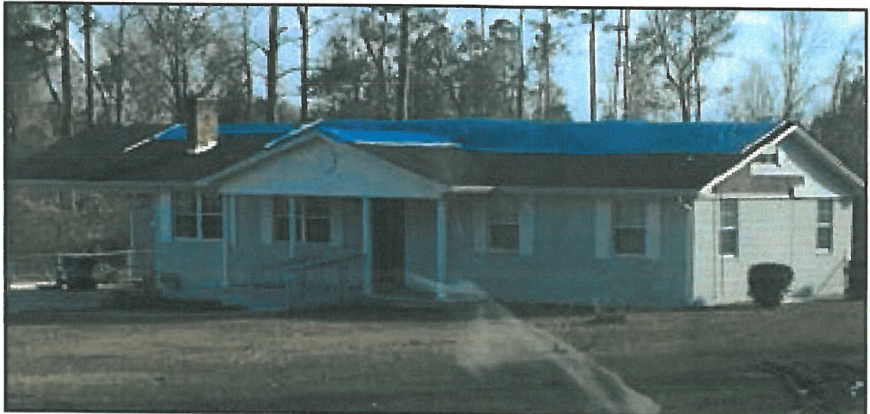
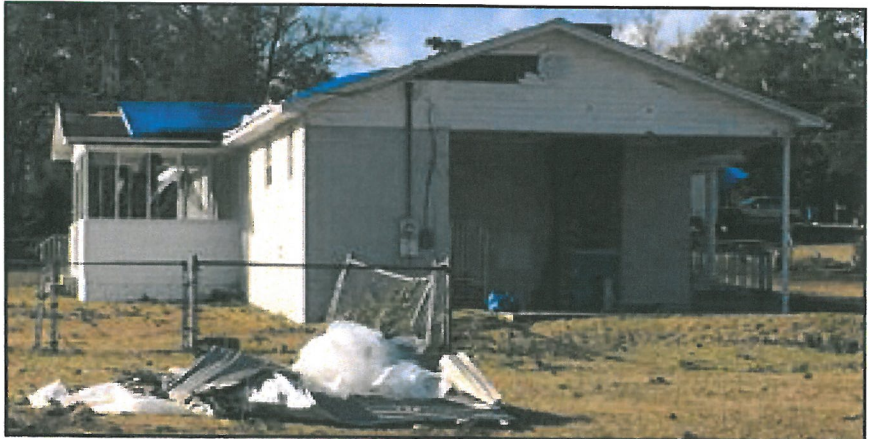
- Loss of some shingles
- Siding damage
- Fence damage
- Slight water damage from water coming through roof deck after shingles removed
- Destroyed 11 trees in their yard
- Screen porch damage

*Front and side views of 111 Upton Road after the tornado.*

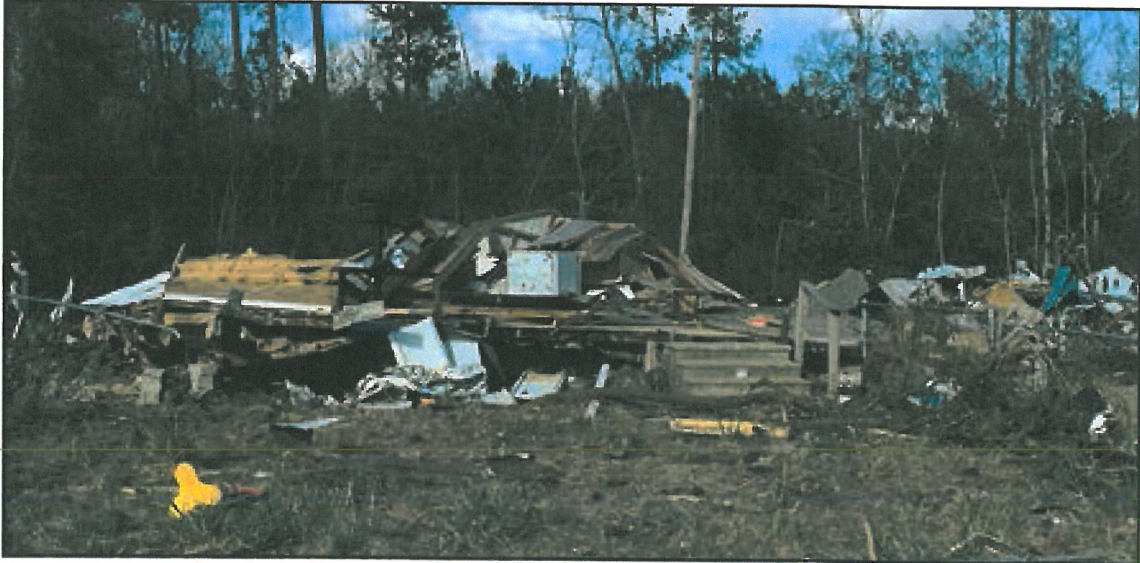
*The tornado destroyed a mobile home across the street and damaged structures on either side of the home at 111 Upton.*

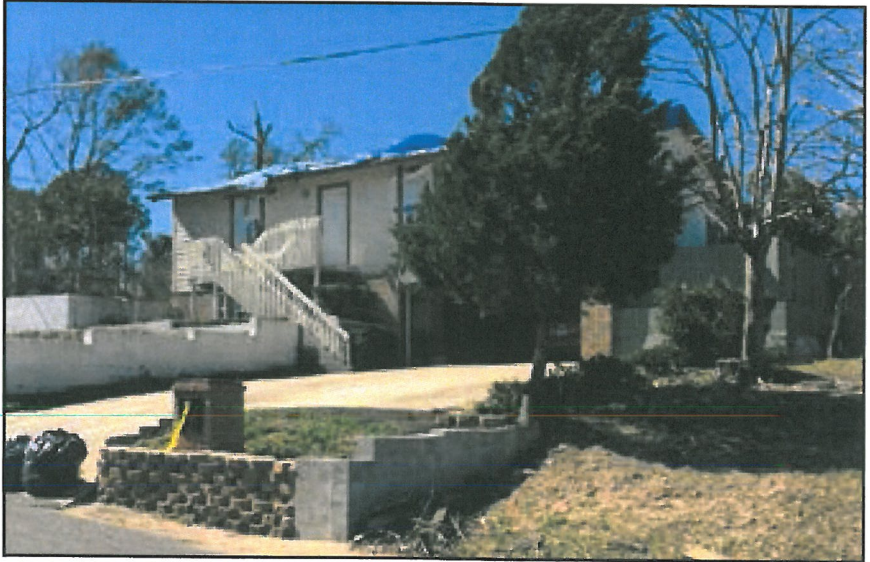
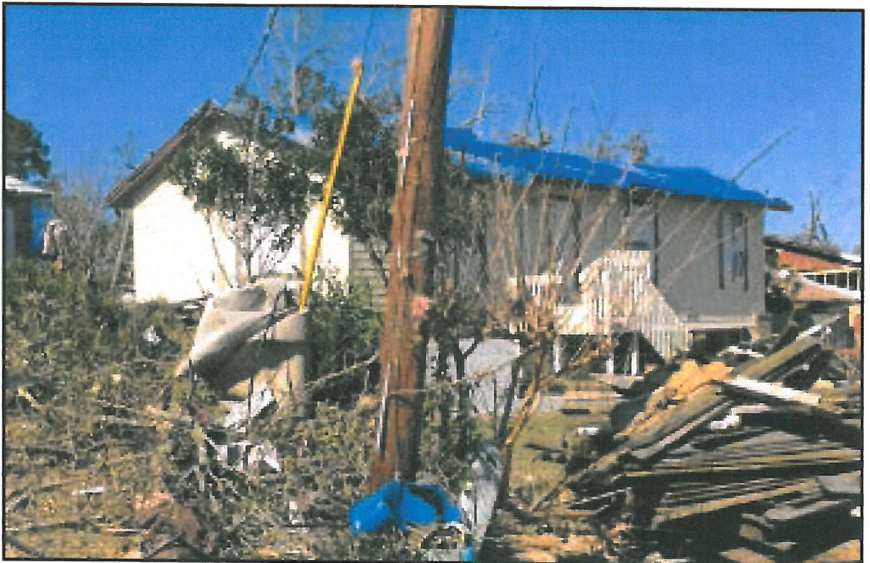
- Loss of some shingles and water damage through the roof
- Window damage (there was not time for shutters to be deployed)
- Tree and fence damage

*Views of 4660 Tradewinds Drive after the tornado*

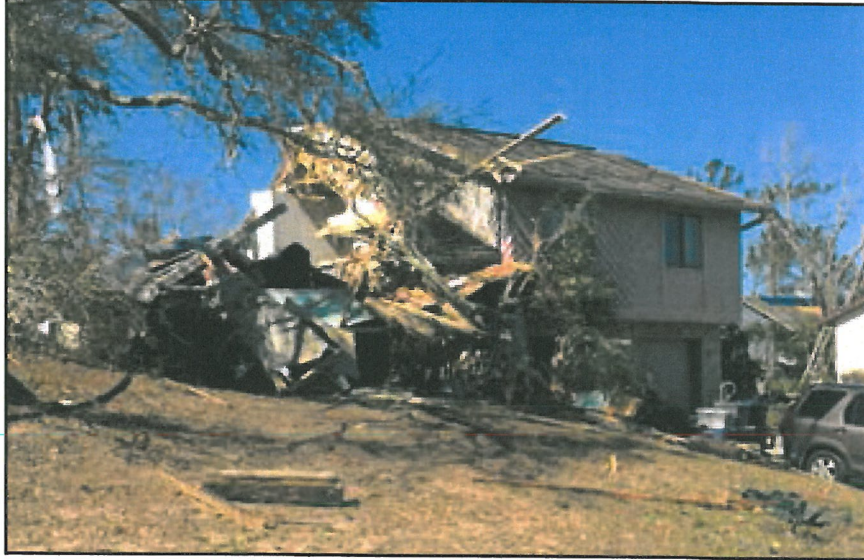
*Destroyed home to the left of 4660 Tradewinds Drive (non-REBUILD home)*

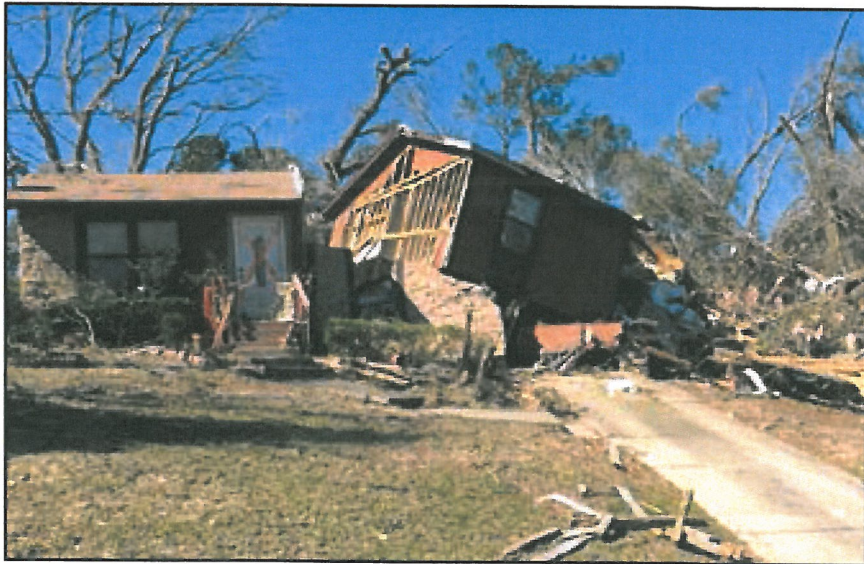
*Destroyed home to the right of 4660 Tradewinds Drive (non-REBUILD home). The garage door's failure likely led to rapid pressurization of the home. We will discuss these and other failures in subsequent sections.*

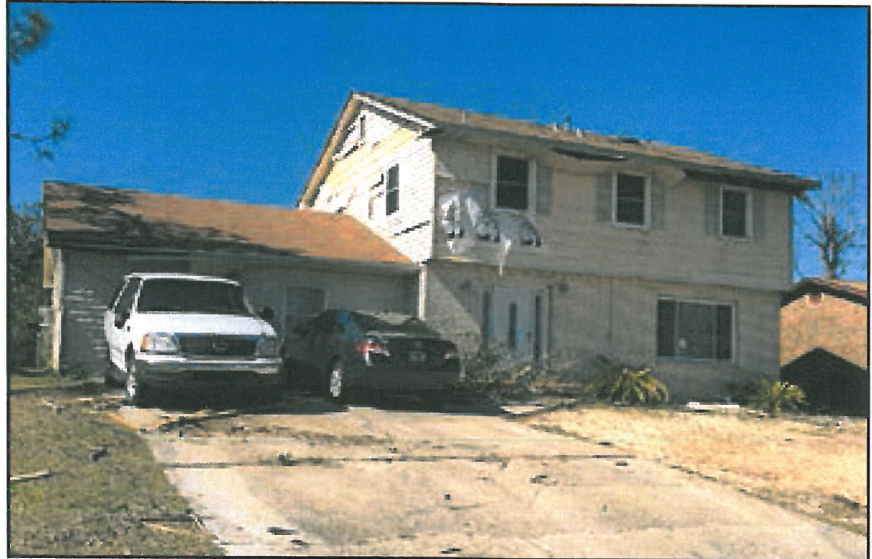
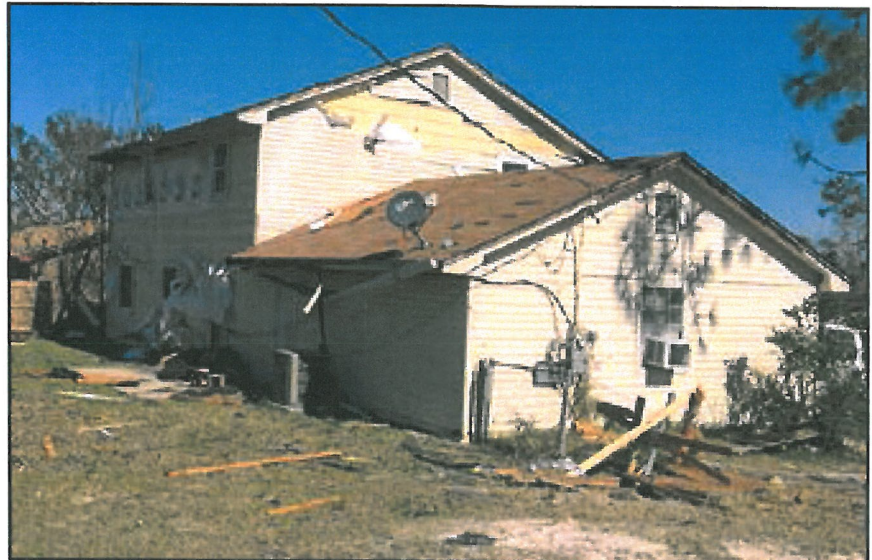
- Loss of shingles
- Loss of vinyl siding
- Loss of vinyl soffits and gutters
- Back porch damaged
- Fences destroyed

*Front and back views of 4700 Anchor Lane after the tornado*

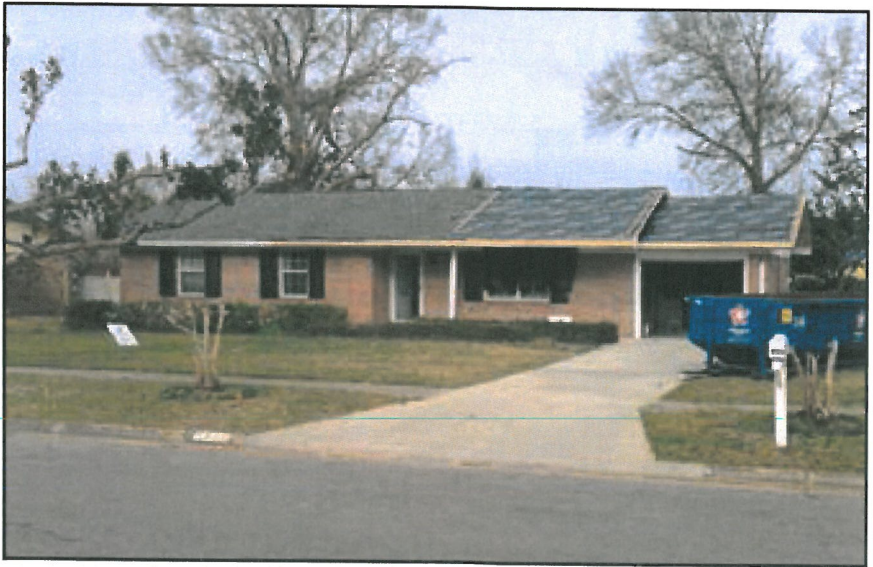
- Loss of some shingles and roof decking damage, primarily above the garage
- Broken front window (there was not time for shutters to be deployed)
- Tree and fence damage

*Front view of 7800 Le Jeune Drive. This home had been repaired and was being re-roofed at the time of our inspection. Note that the gable-end-bracing REBUILD had installed on the garage gable held, preventing the gable truss from failing and causing more extensive damage.*

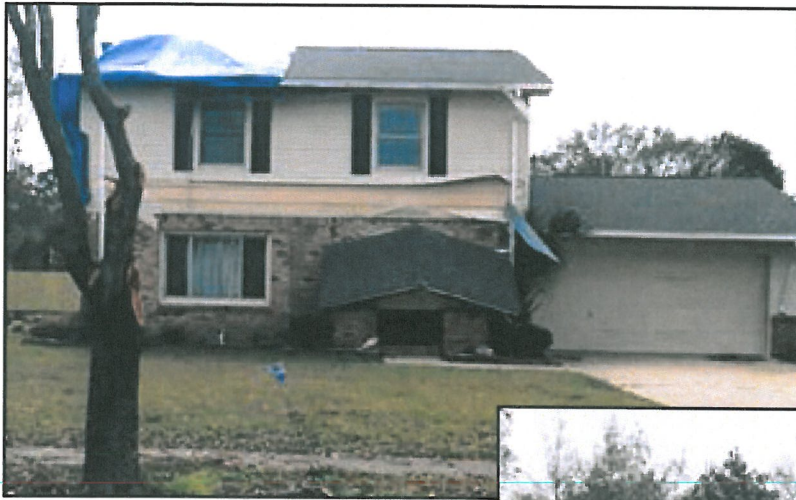
*Heavily damaged/possibly destroyed homes across the street from 7800 Le Jeune Drive (non-REBUILD homes)*

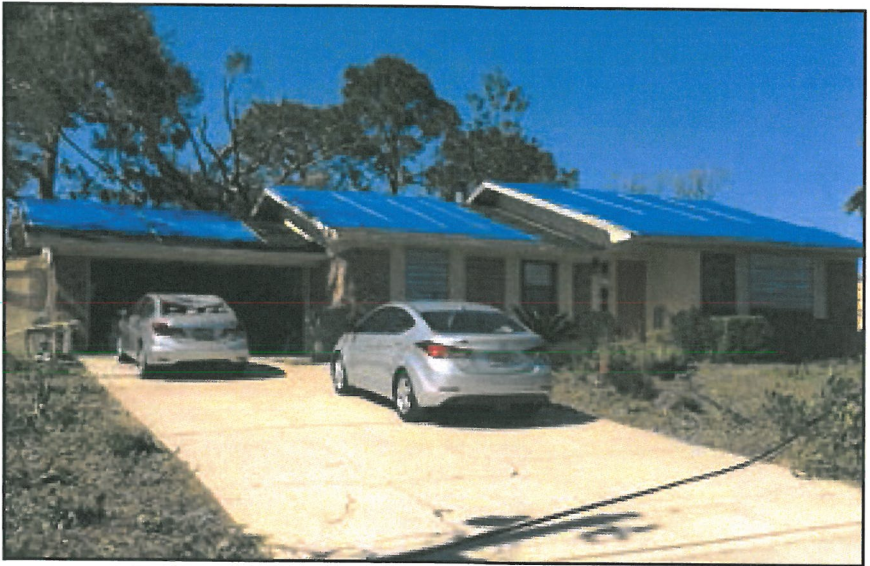
- Loss of shingles and ridge vent
- Fences destroyed
- Garage door dings

*View of 4720 Tradewinds Drive after the tornado*

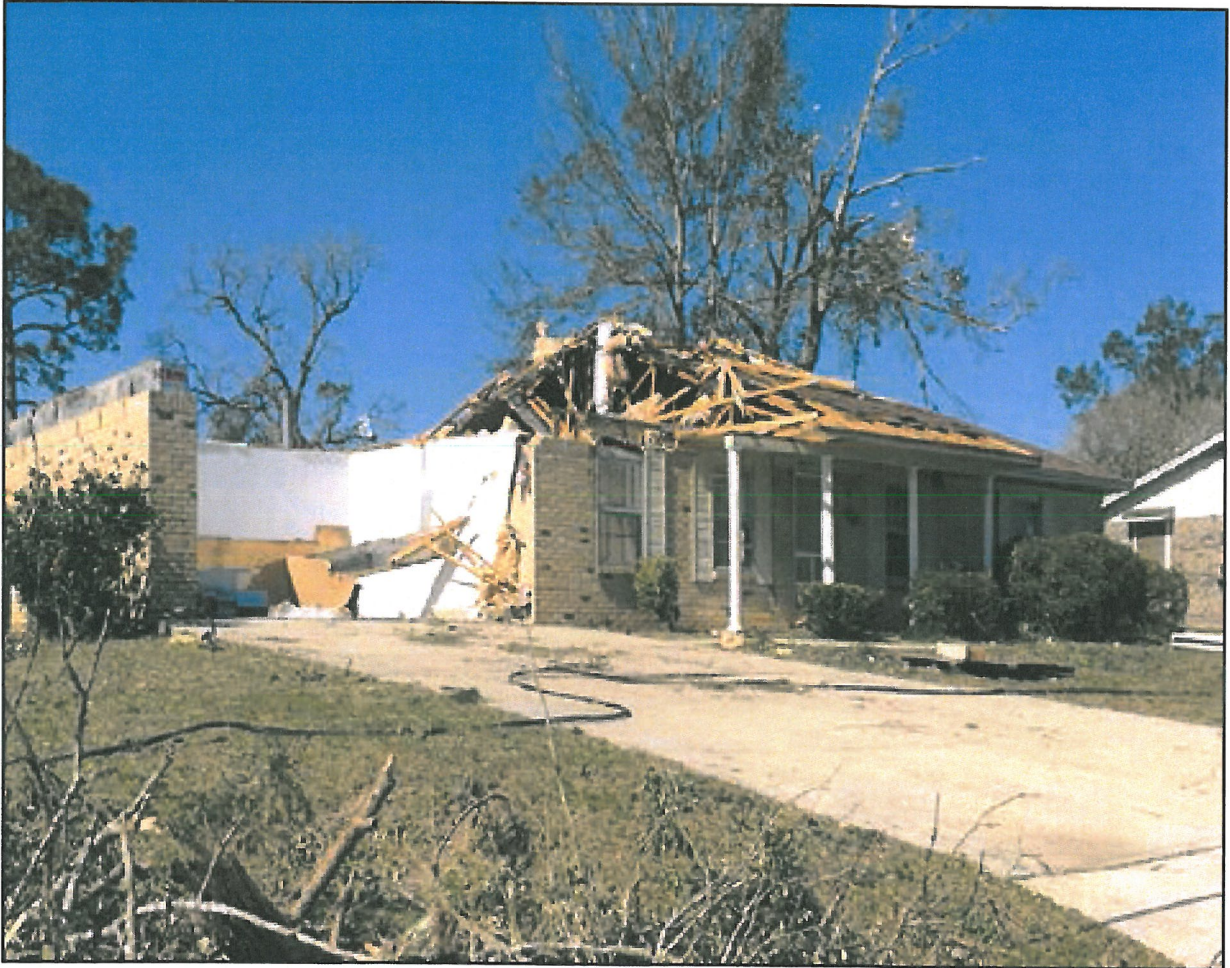
Approximately 20 feet away, the home next to 4720 Tradewinds Drive was destroyed. Garage door failure likely led to rapid pressurization of this non-REBUILD home.

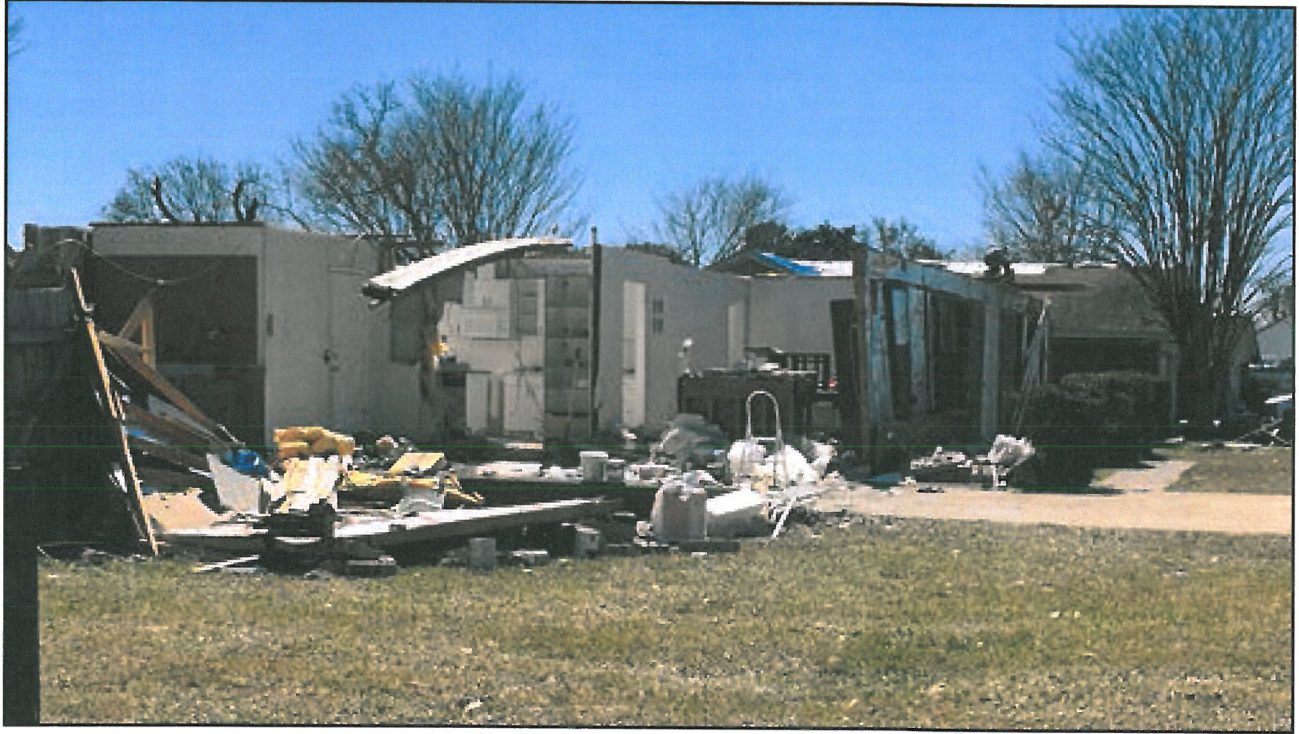
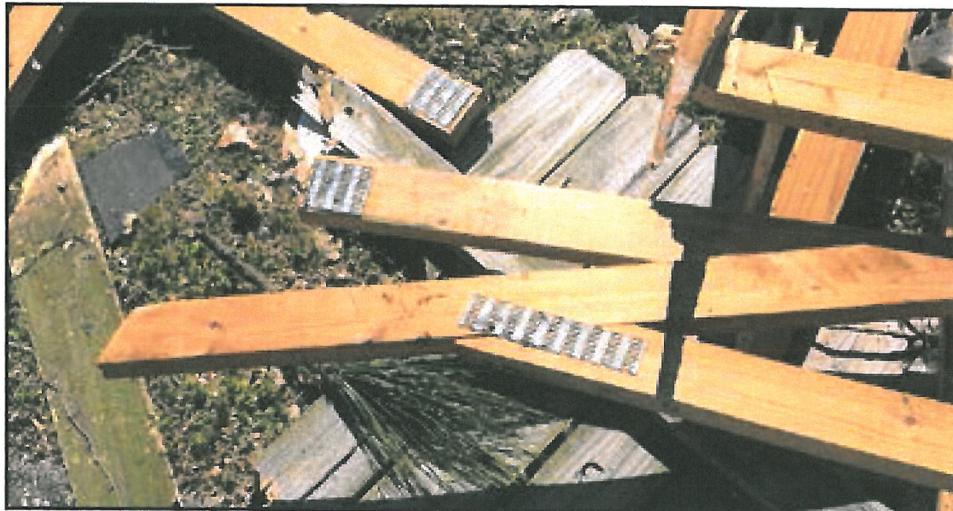
REBUILD installs hurricane clips to homes it retrofits. Lack of hurricane clips appears to be a contributing factor to damage to multiple homes.

*No clips on any of the trusses from the debris pile of this home (non-REBUILD home).*

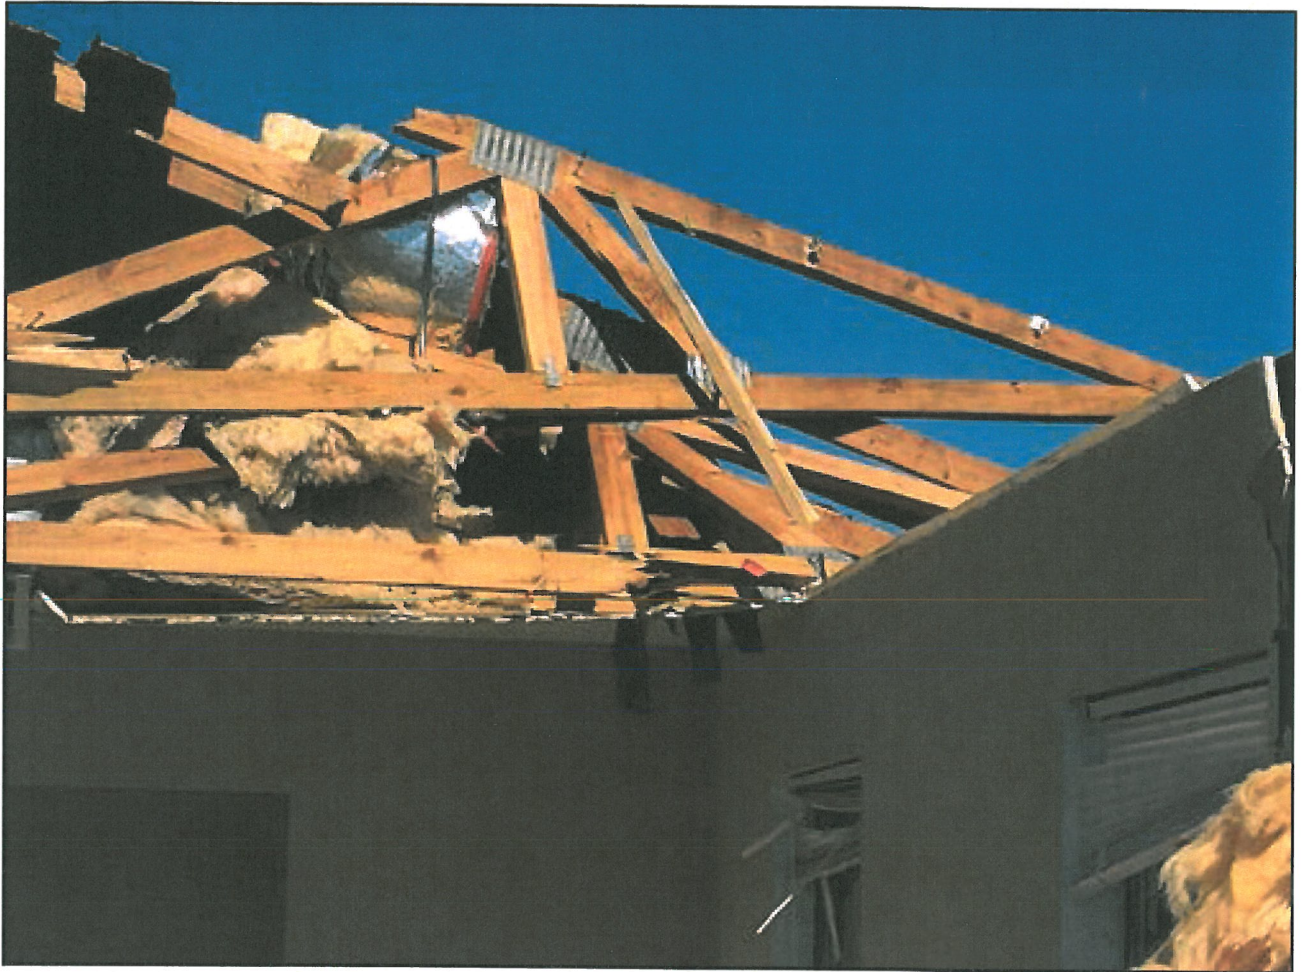
*No clips on any of the trusses on this non-REBUILD home*

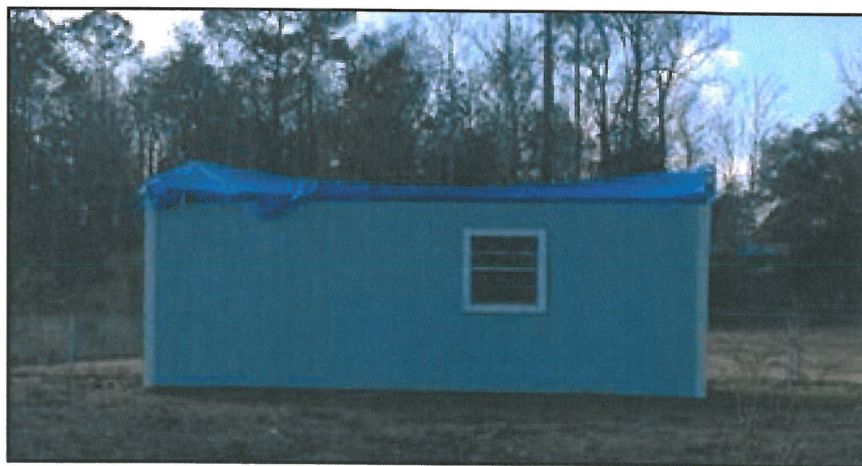
*Roof-to-wall failure of an out-building (not hardened by REBUILD) on the property of 111 Upton in Century*

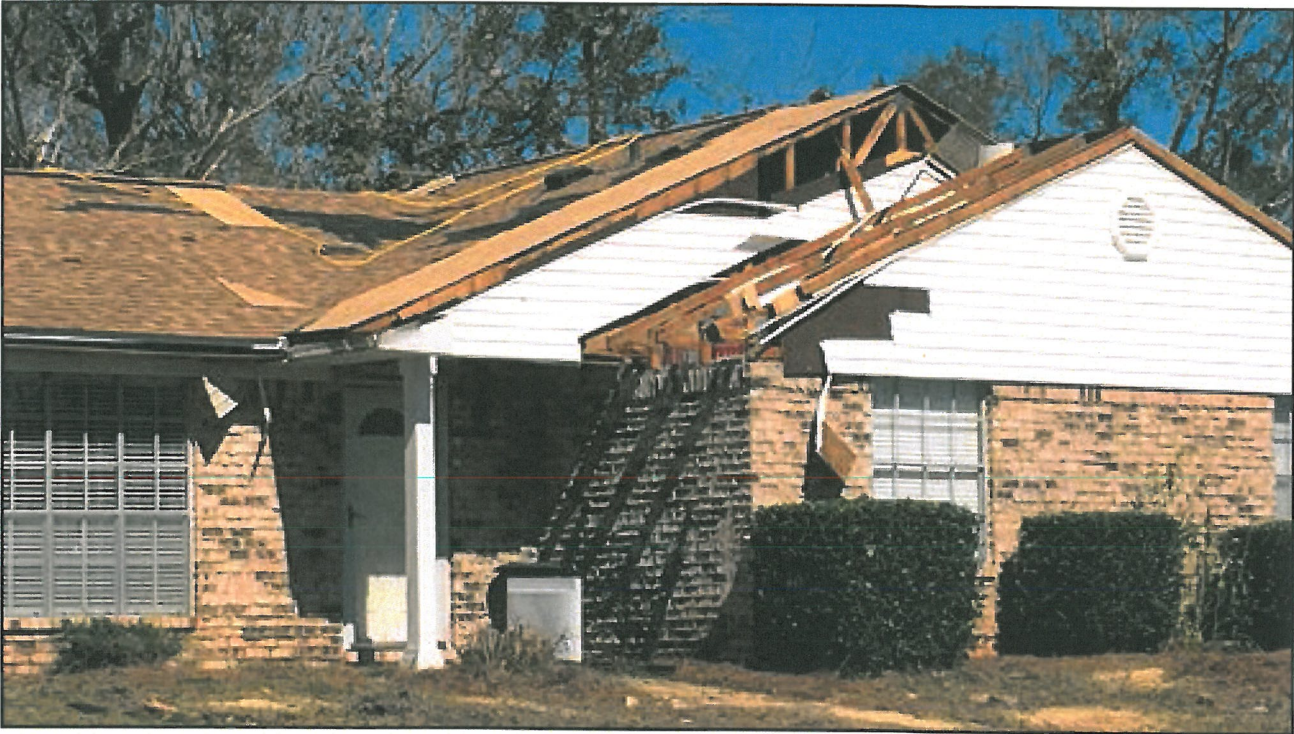
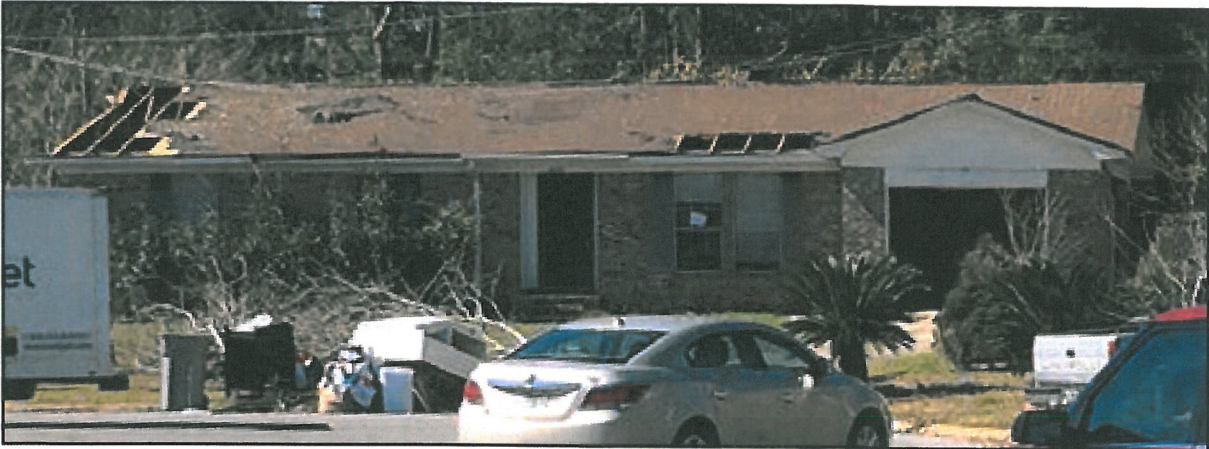
Roof deck failure was common on these and other non-REBUILD homes located in the damage path.

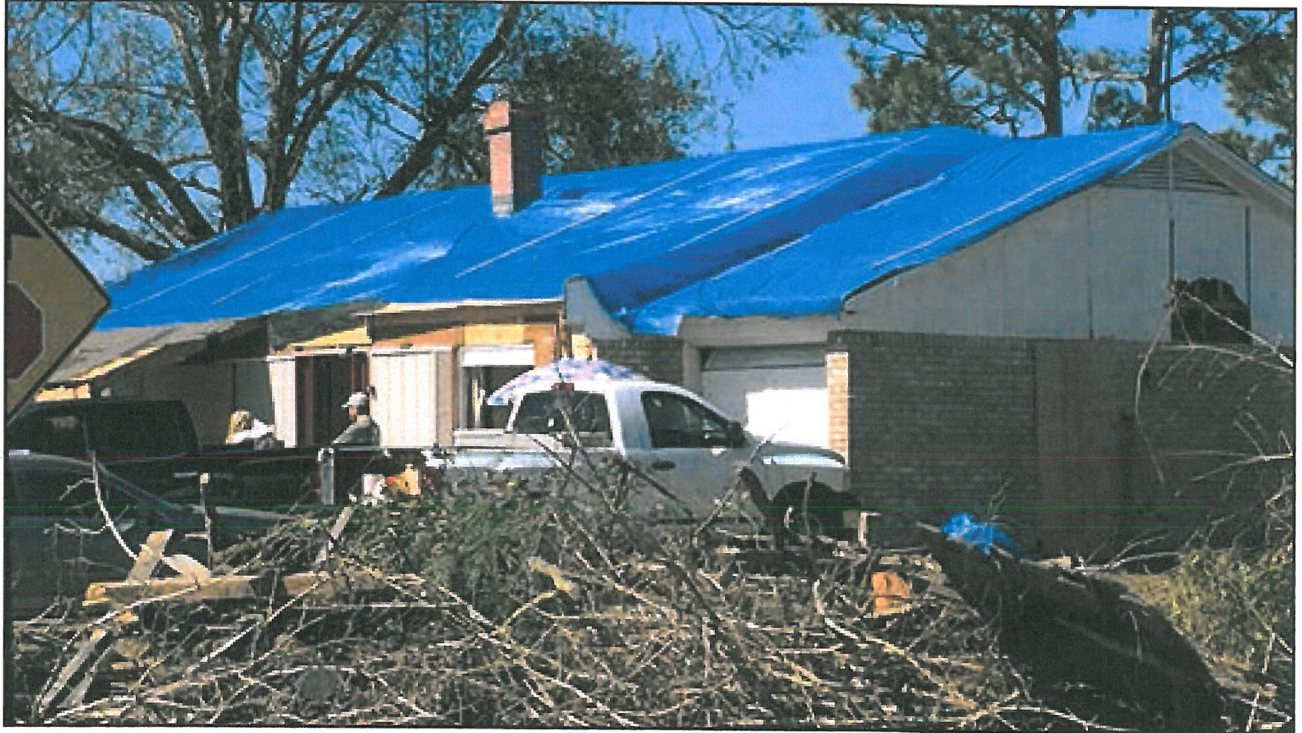
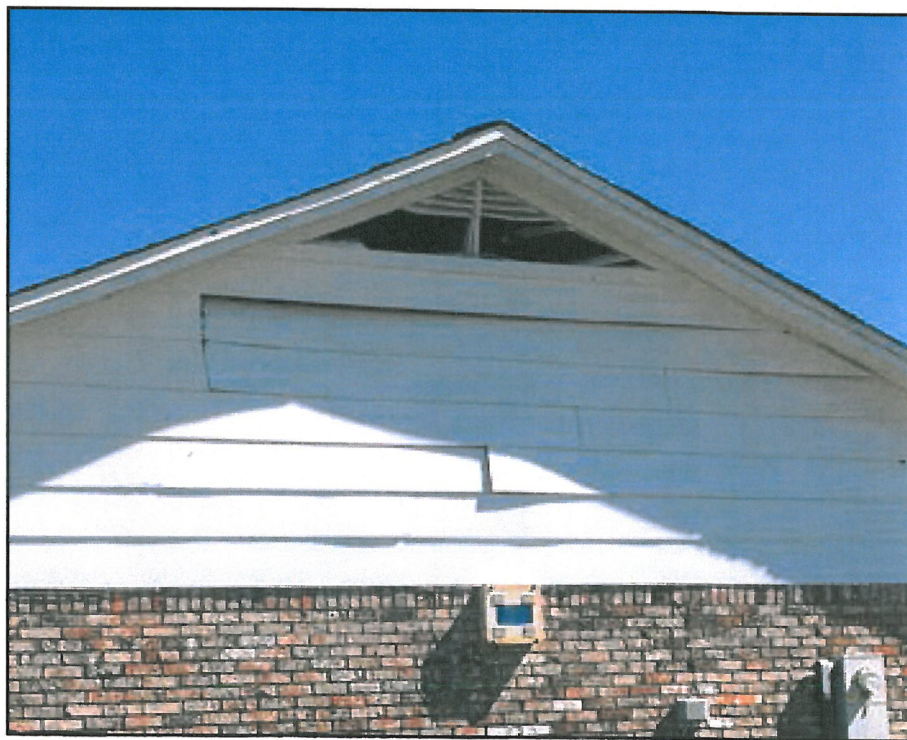
We were thankful to see no gable-end failures that led to other major damage; however, we did find several gable-ends that the storm had damaged.

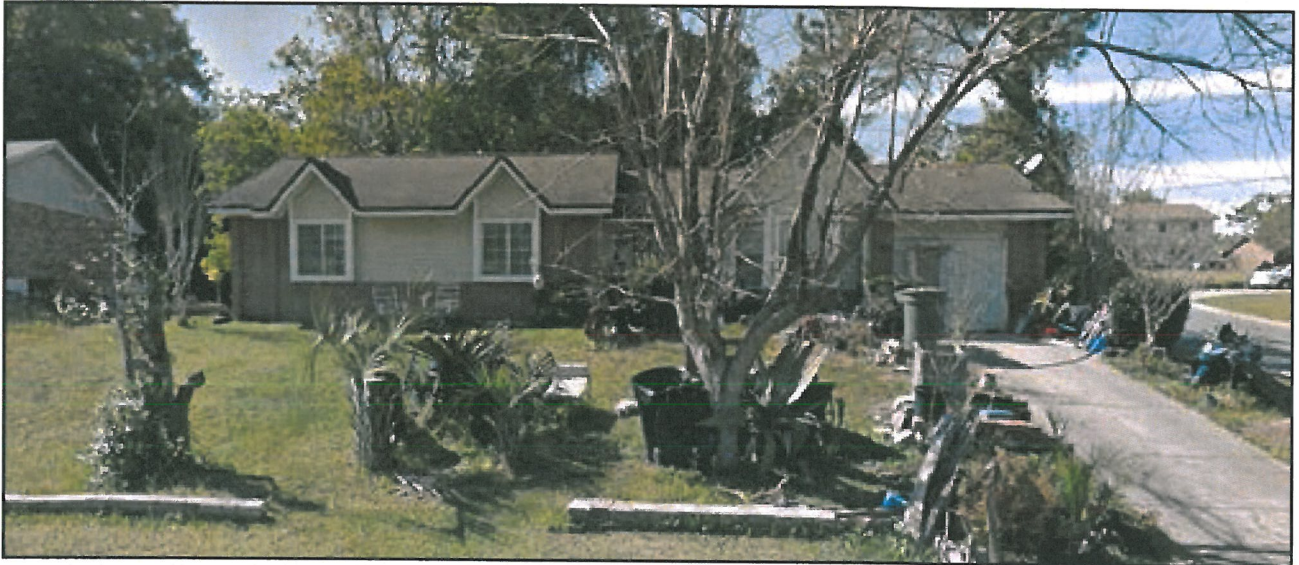
We noticed many garage doors that had failed during the storm. These two photos show the same non-REBUILD home before and after the tornado.

*Non-REBUILD home prior to the storm*

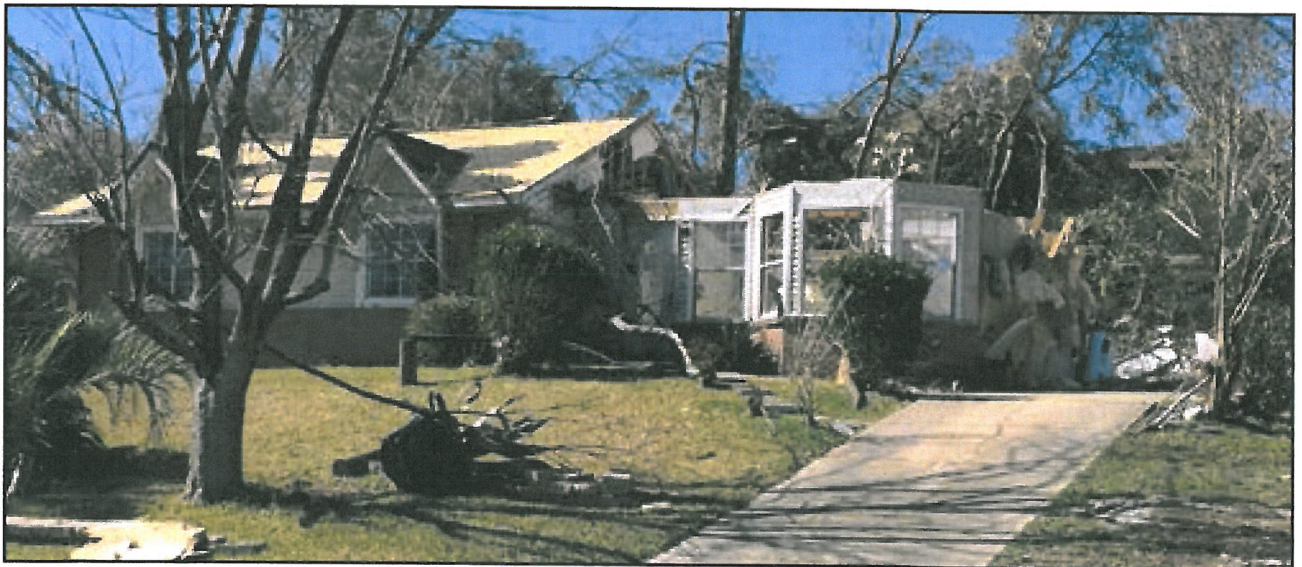
As on many homes we saw, the failure of this home's garage door likely led to rapid pressurization of the home, which in turn caused the roof to collapse and the home to be destroyed.

*Same home after the storm*

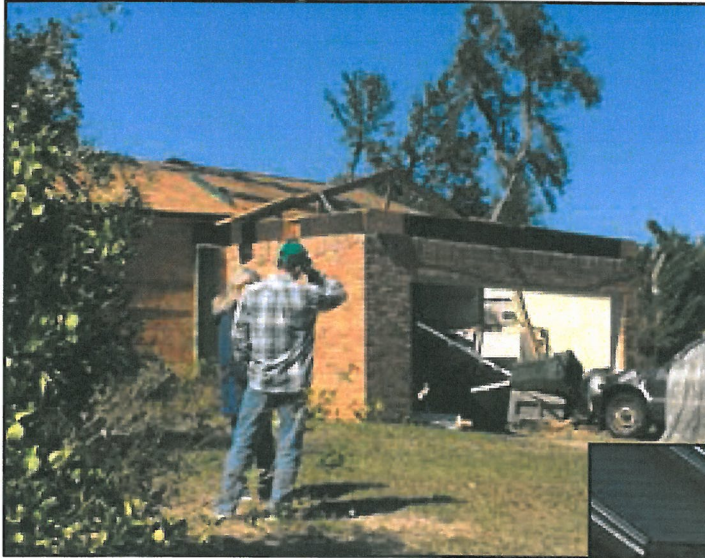
*Garage door failure likely led to rapid pressurization of the garage on this non-REBUILD home.*

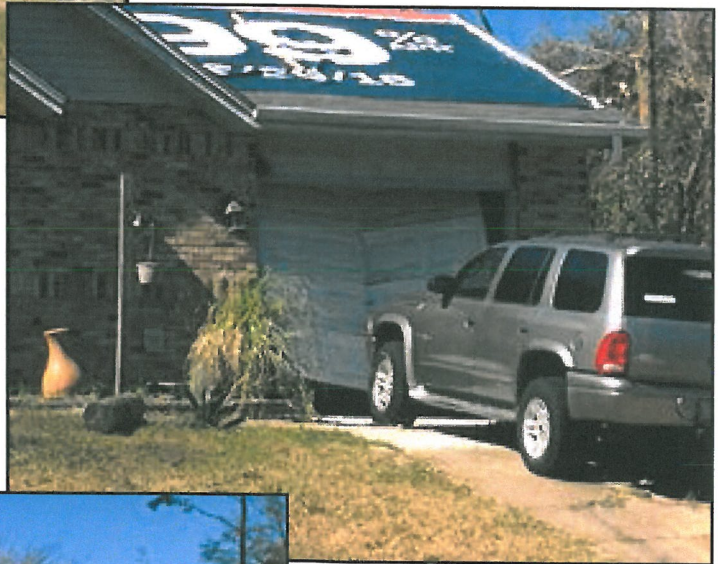
*On this non-REBUILD home, the garage door appears to have held enough to prevent rapid pressurization.*

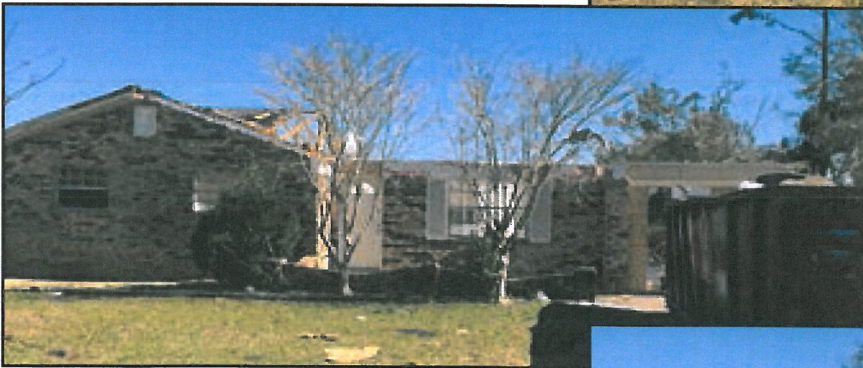
*Garage door failure likely led to rapid pressurization of home (non-REBUILD home).*

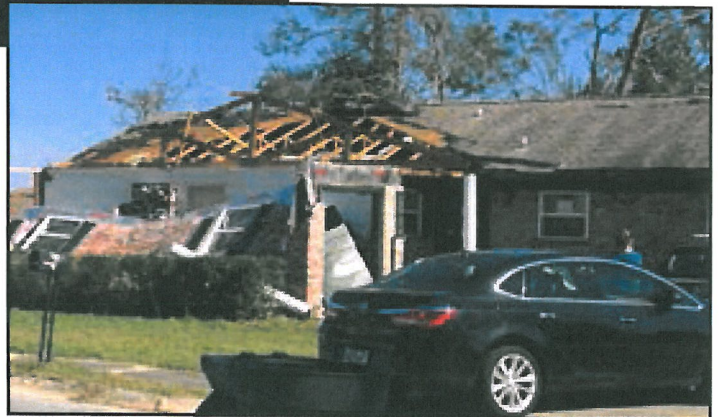
*Garage door failure likely led to rapid pressurization of home (non-REBUILD home).*

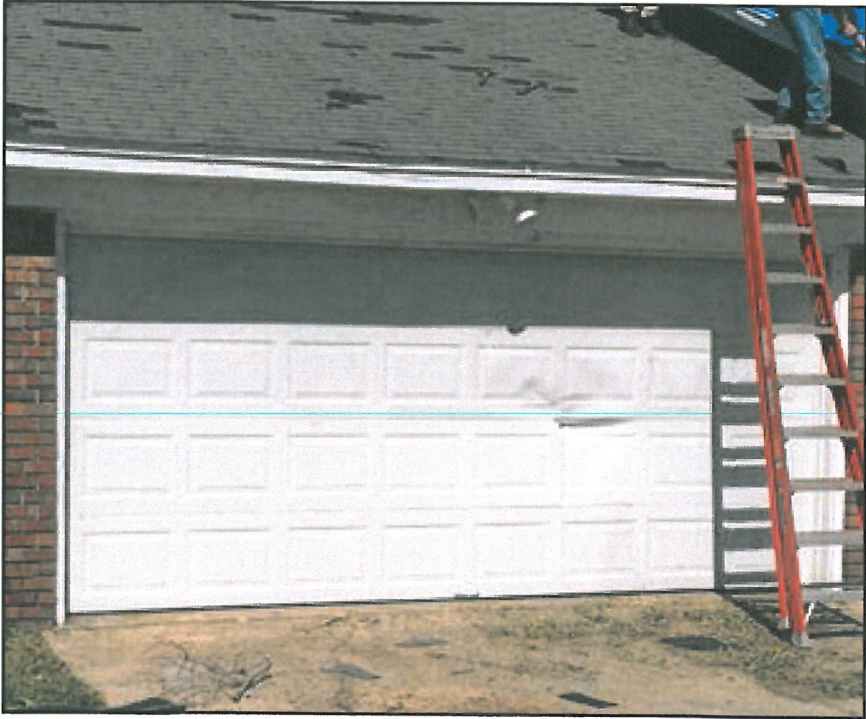
*REBUILD home with a new garage door impacted by a tree.*

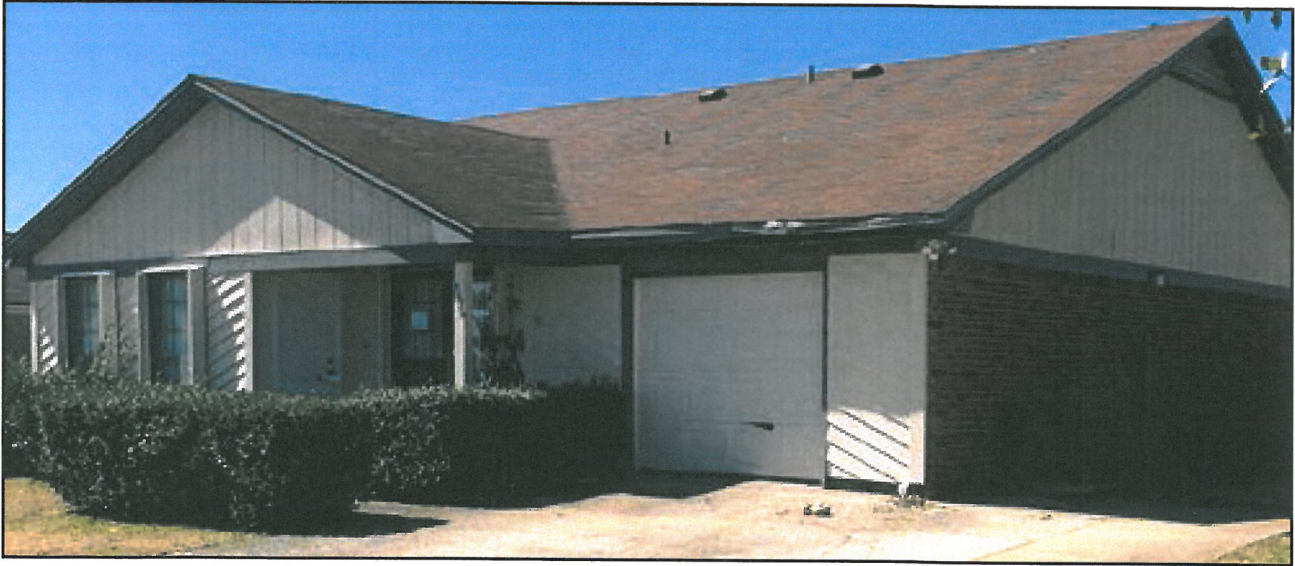
*REBUILD home with a new garage door impacted by windborne debris from the destroyed home across the street.*
