# HOME HARDENING MATTERS

**Special Report on Efficacy of Hurricane Wind Mitigation  
Measures Against EF3 Tornadoes  
Escambia County, Florida • February 2016**

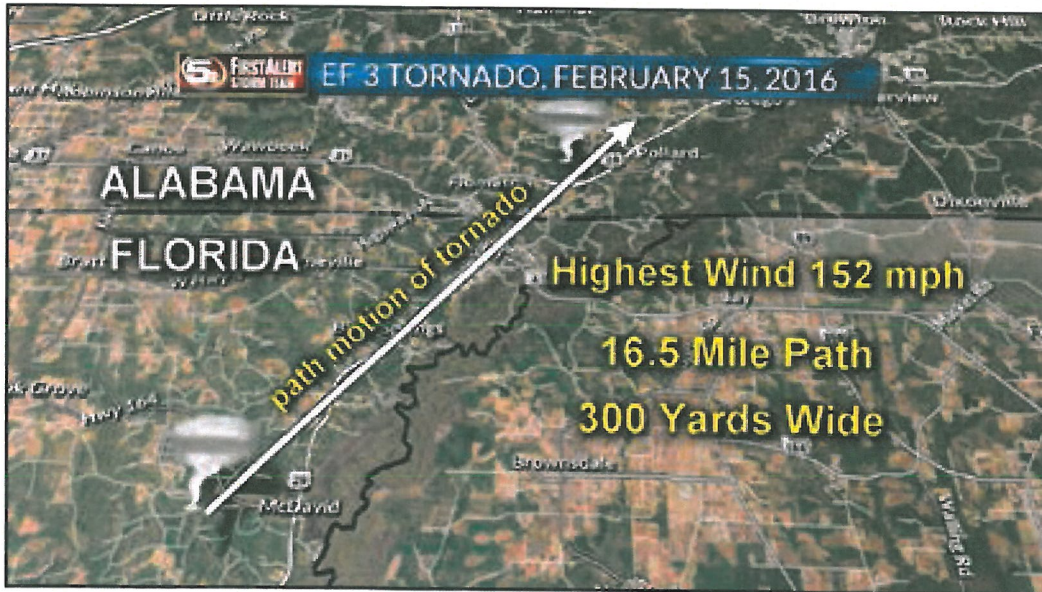
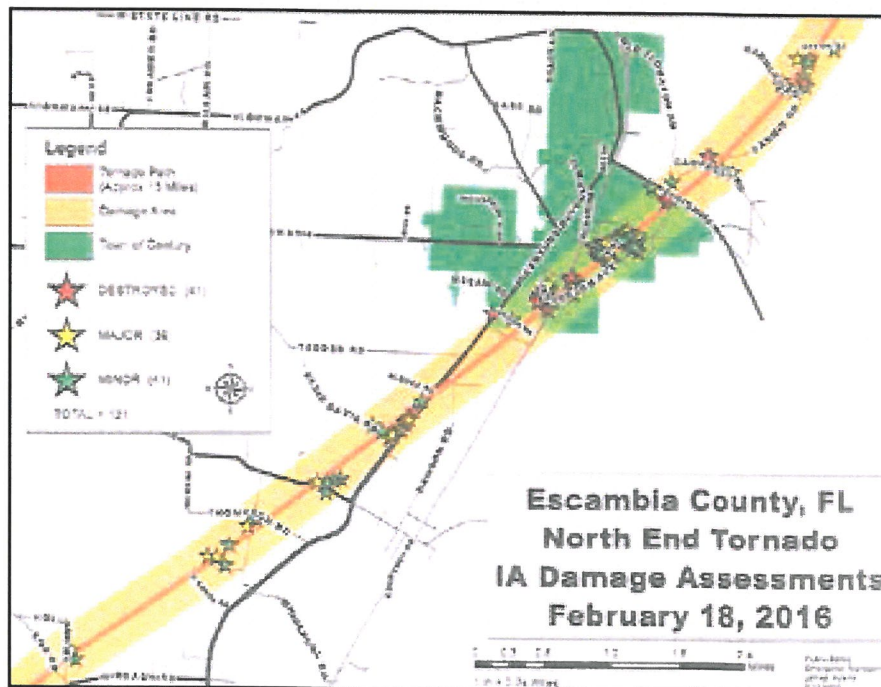
On February 15, 2016, an EF3 tornado passed through the northeastern section of Escambia County, primarily affecting the town of Century, Florida.

Escambia County performed damage assessment and found 121 homes with reportable damage. REBUILD had retrofitted 19 homes within the damage path (150 yards either side of the centerline). Escambia County's list of damaged homes did not include any of the 19 homes that REBUILD had retrofitted.

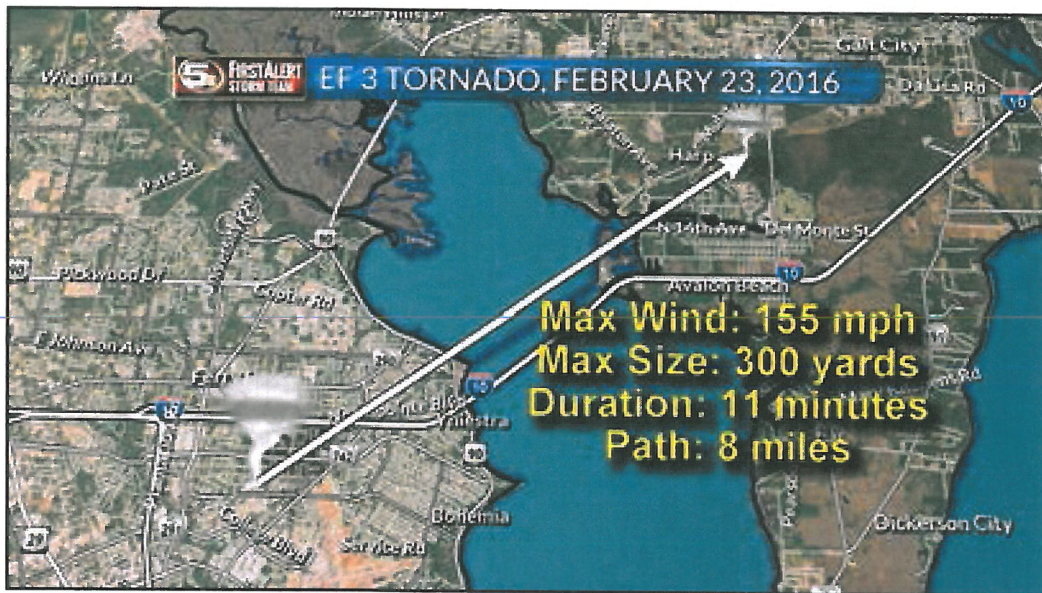
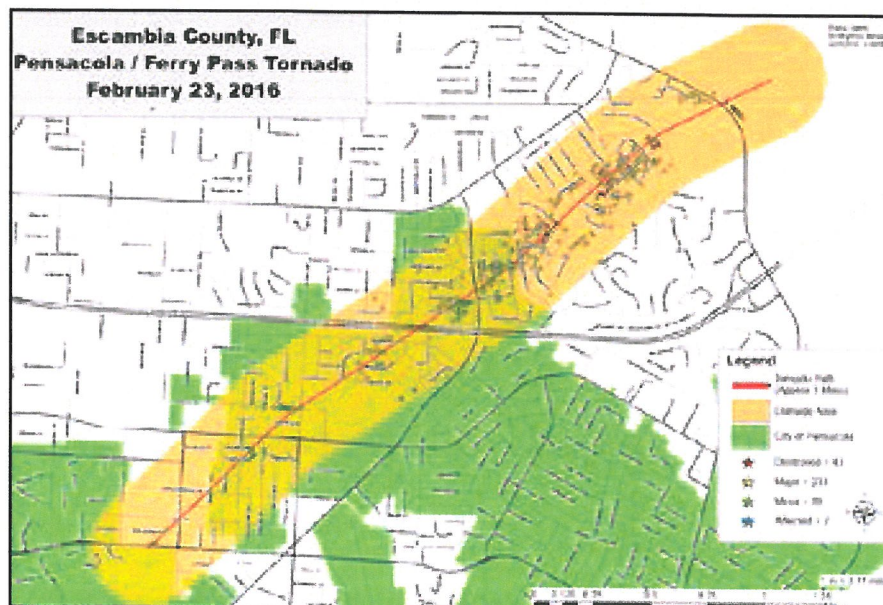
On February 23, 2016, an EF3 tornado passed through the Ferry Pass community of northeast Pensacola. The impacted area was primarily residential neighborhoods, but also included commercial and industrial areas.

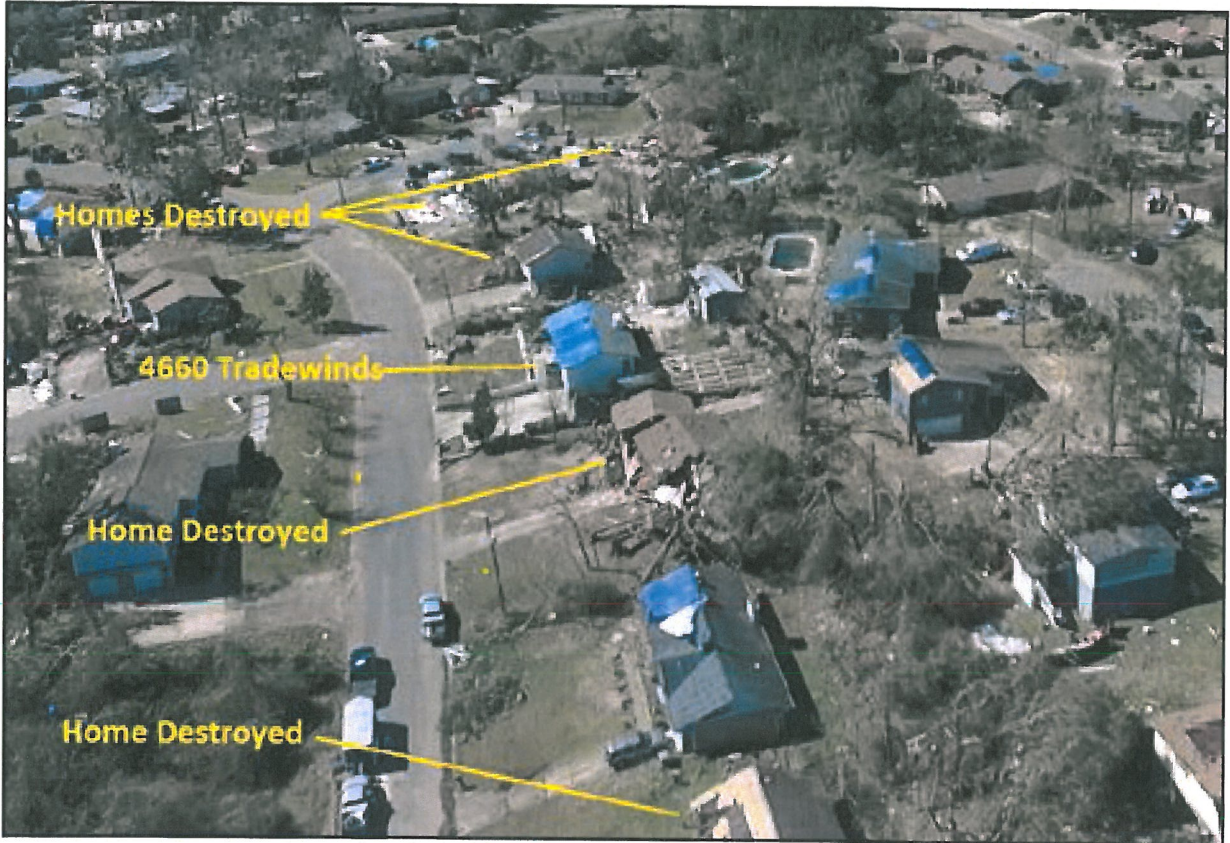
*Drone view of 4660 Tradewinds Drive and surrounding non-REBUILD homes*

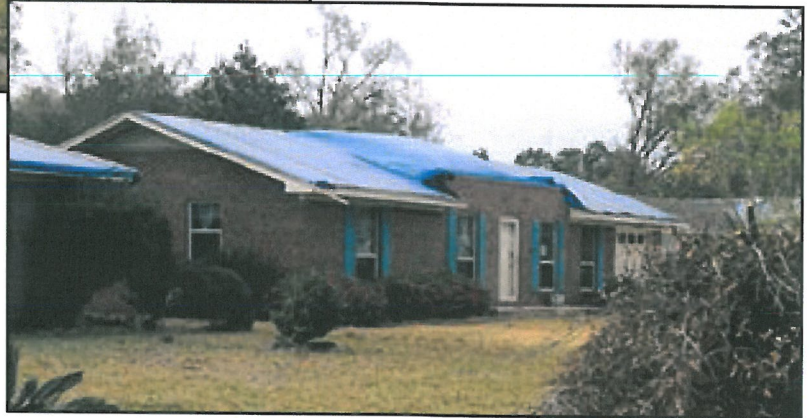
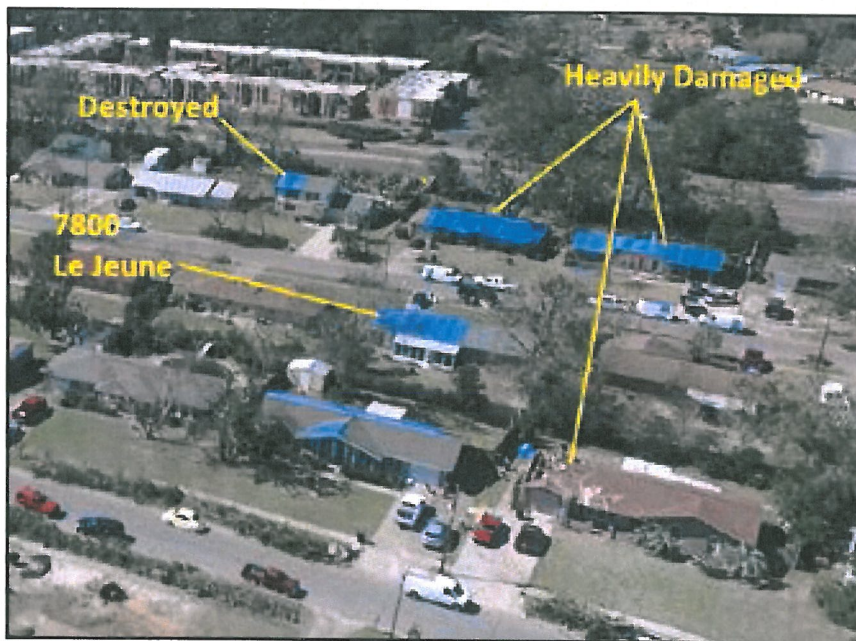
*Drone view of 7800 Le Jeune Drive and surrounding non-REBUILD homes*
